FINAL WATER QUALITY PROJECT REPORT

WQC-2023-C1CHHS-00131

Pollution Identification and Correction (PIC)
Sequim Bay–Dungeness Clean Water District Watersheds

Clallam County Health & Human Services–Environmental Health

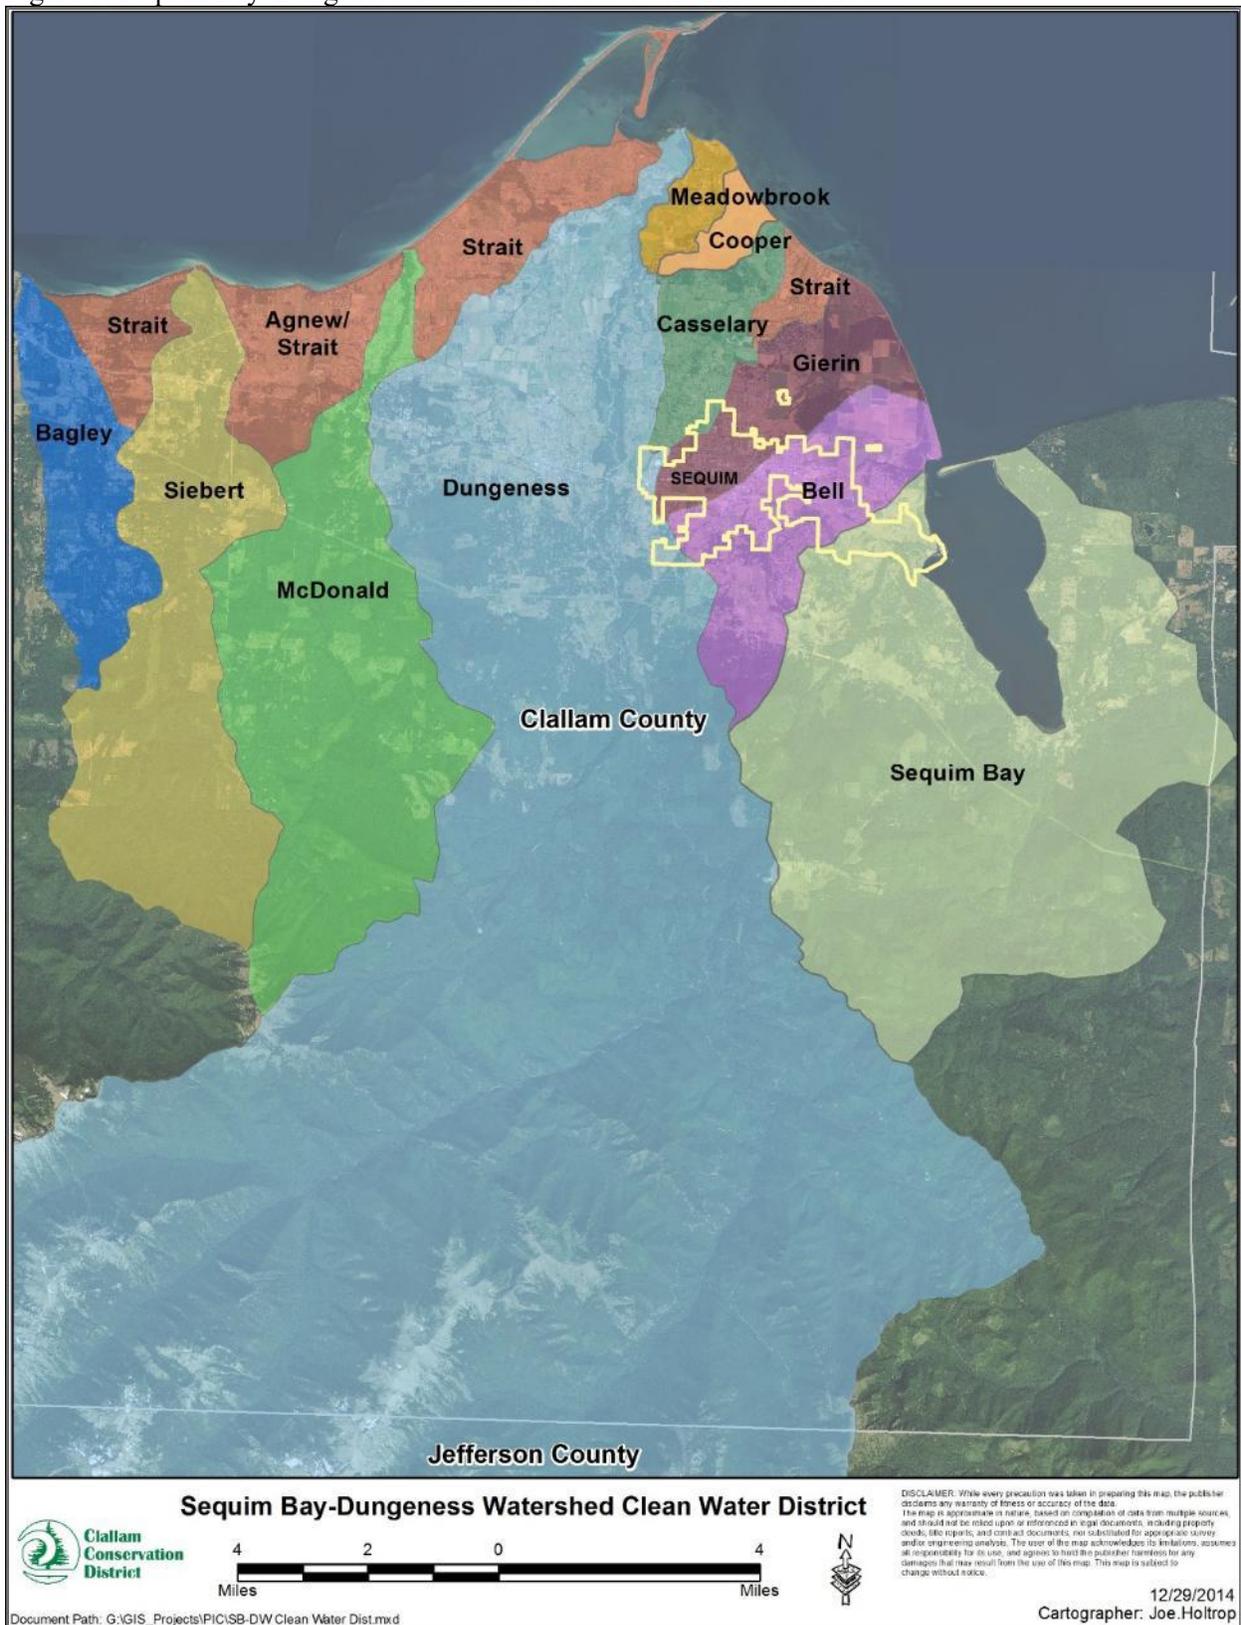
Figure 1. Sequim Bay–Dungeness CWD and its constituent sub-watersheds.

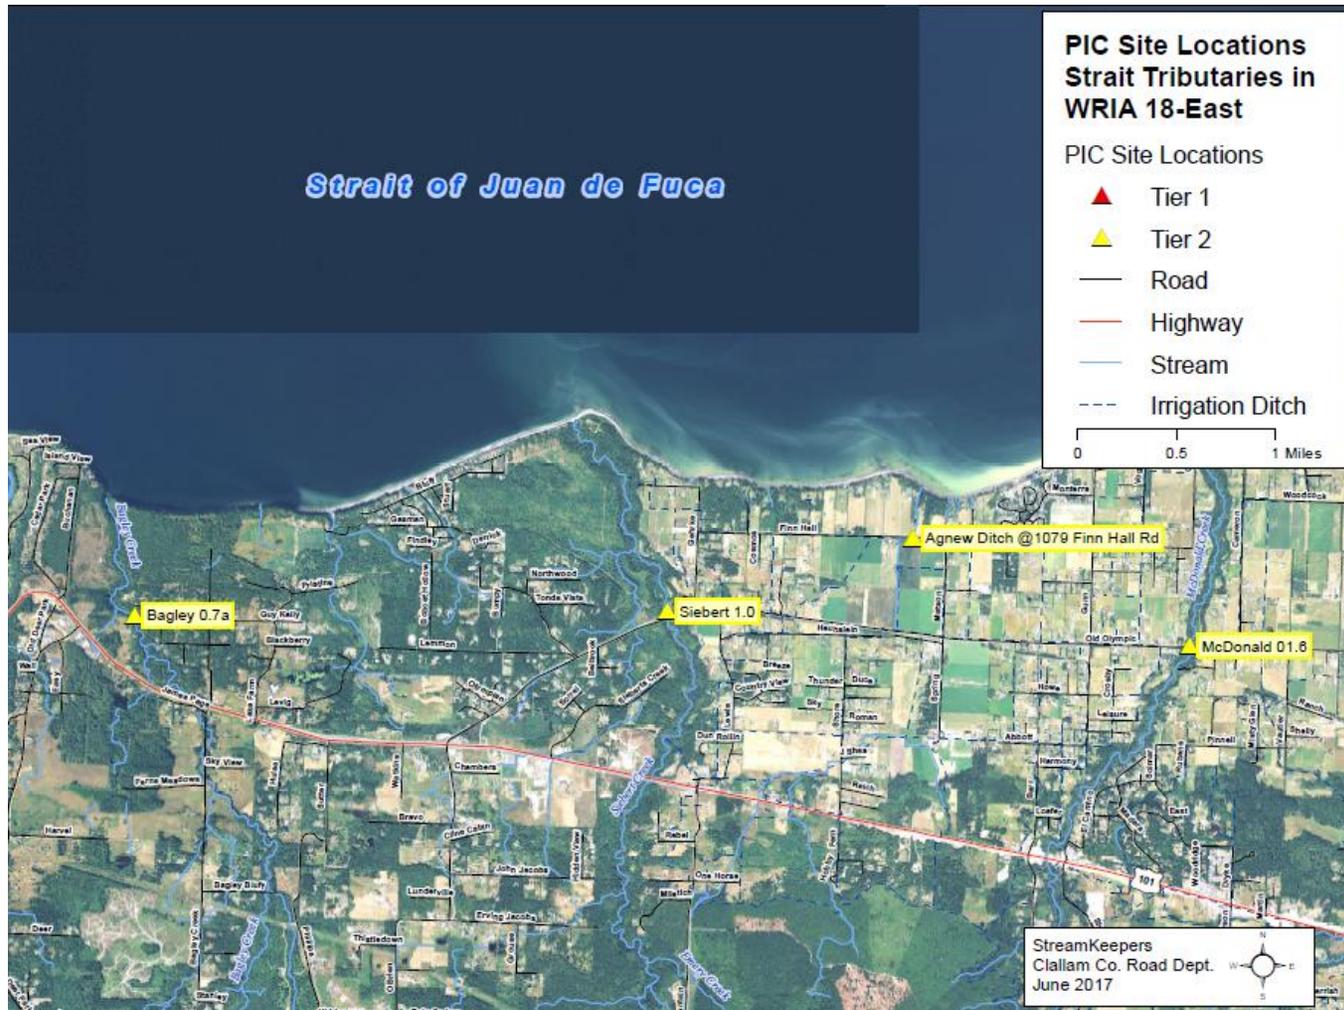
Figure 6. Baseline Trends Monitoring sites draining to the East Straits Growing Area.

Figures 6-8 map Baseline Trends Monitoring sites. Mapped Tiers reflect 2015-2023 designations; in January 2024 the following Tier designations were altered:

- Agnew Ditch and McDonald Creek were moved from Tier II to Tier I (Figure 6)
- Cooper Creek was moved from Tier I to Tier II and Gierin Creek from Tier II to Tier I (Figure 7)
- Johnson, SB State Park, and Jimmycomelately Creeks were moved from Tier I to Tier II (Figure 8)

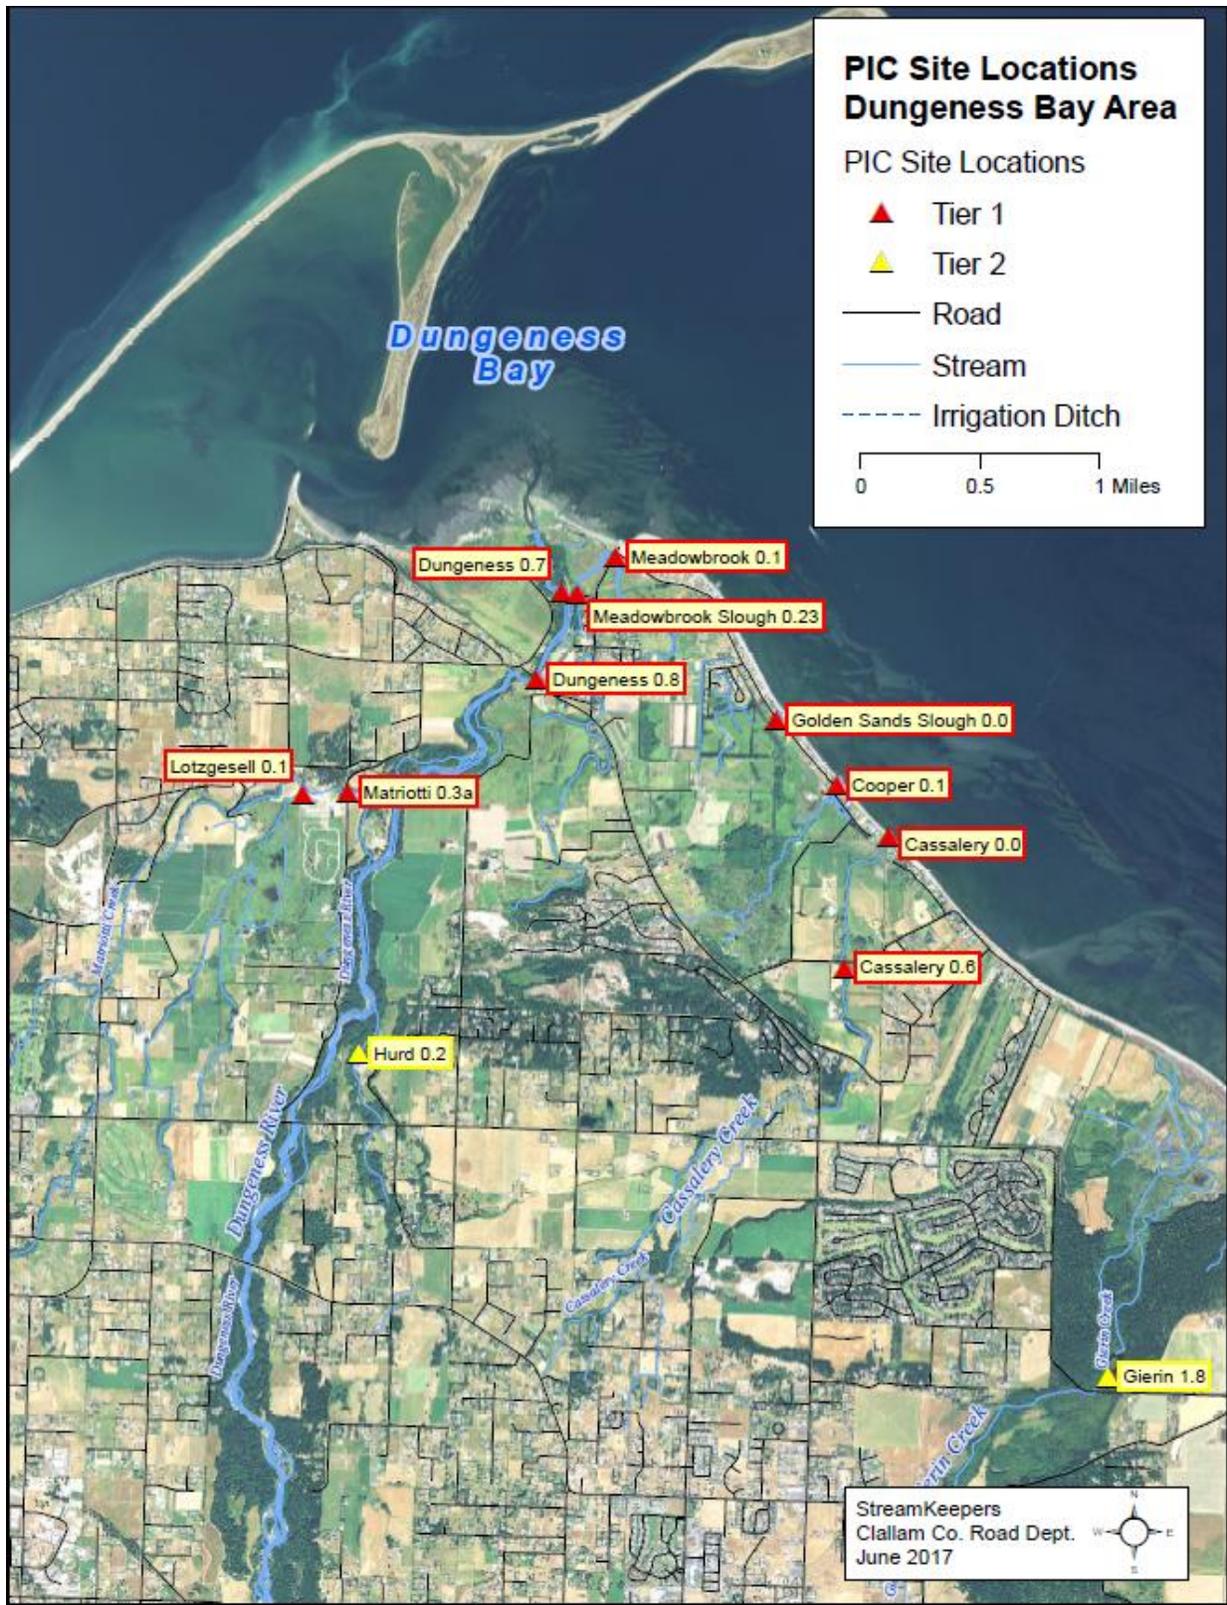
Figure 7. Baseline Trends Monitoring sites draining to the Dungeness Bay and Jamestown Growing Areas.

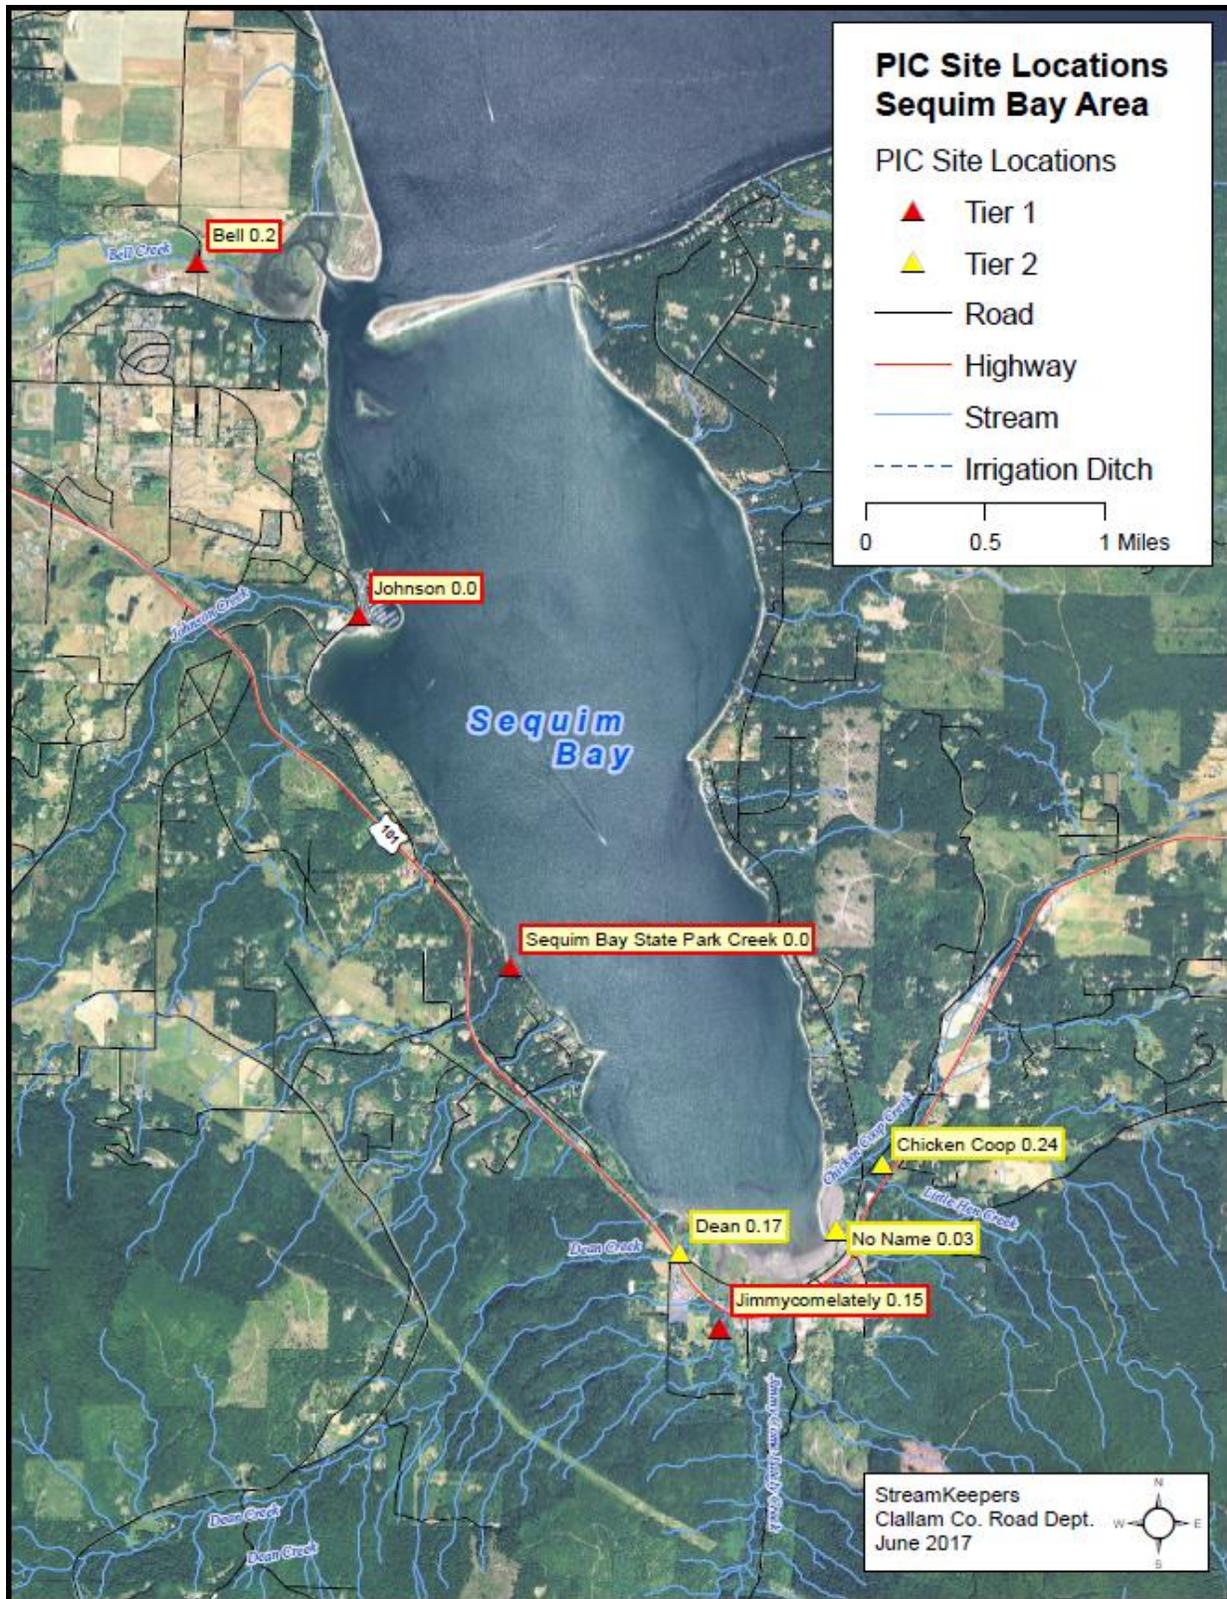
Figure 8. Baseline Trends Monitoring sites draining to the Sequim Bay Growing Areas.

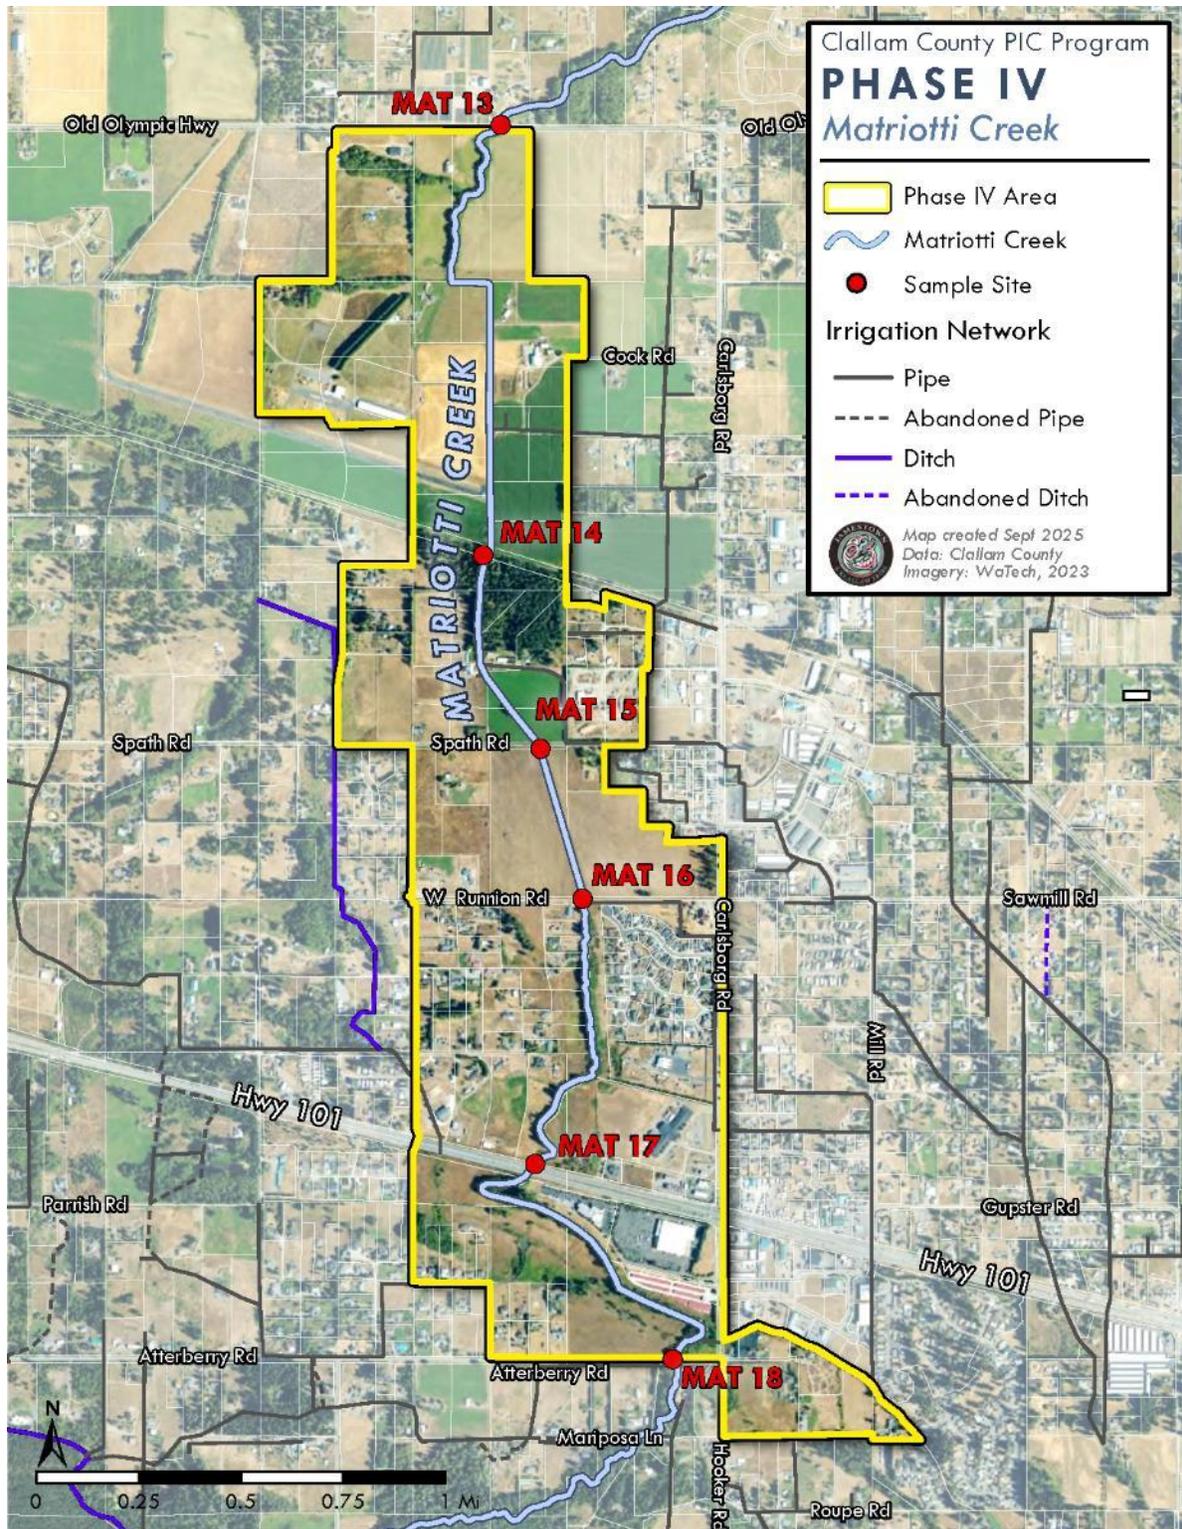
Figure 10. Sequim Bay–Dungeness CWD PIC Phase IV (2023-2025) Upper Matriotti Creek Focus Area Segmented Sampling locations.

Primary MAT Segmented locations (Figure 10) were sampled monthly, from April 2024 through December 2025, with three exceptions (05/2024, 12/2024, and 01/2025). MAT13, the northernmost and lowest point in the Focus Area, was seasonal/ephemeral as a result of soil permeability and/or control of irrigation tailwater discharges. This was also the observed conditions of sampling stations upstream through MAT16. The natural filtration processes occurring in this stretch may explain bacteria concentrations that were typically lower than those above MAT16—and consistently fell in the medium-priority, or lower, category for follow-up sampling—or the resurfacing waters during irrigation season may be solely from controlled inputs. Due to the ephemeral nature of these sites, hot spot tracing was not initiated. Stations MAT17 and MAT18, primarily fed by groundwater, had greater permanency of flow. Fecal coliform concentrations at MAT18 were commonly elevated into the high-priority follow-up category-range, directing hot spot and correction efforts upstream of this location.

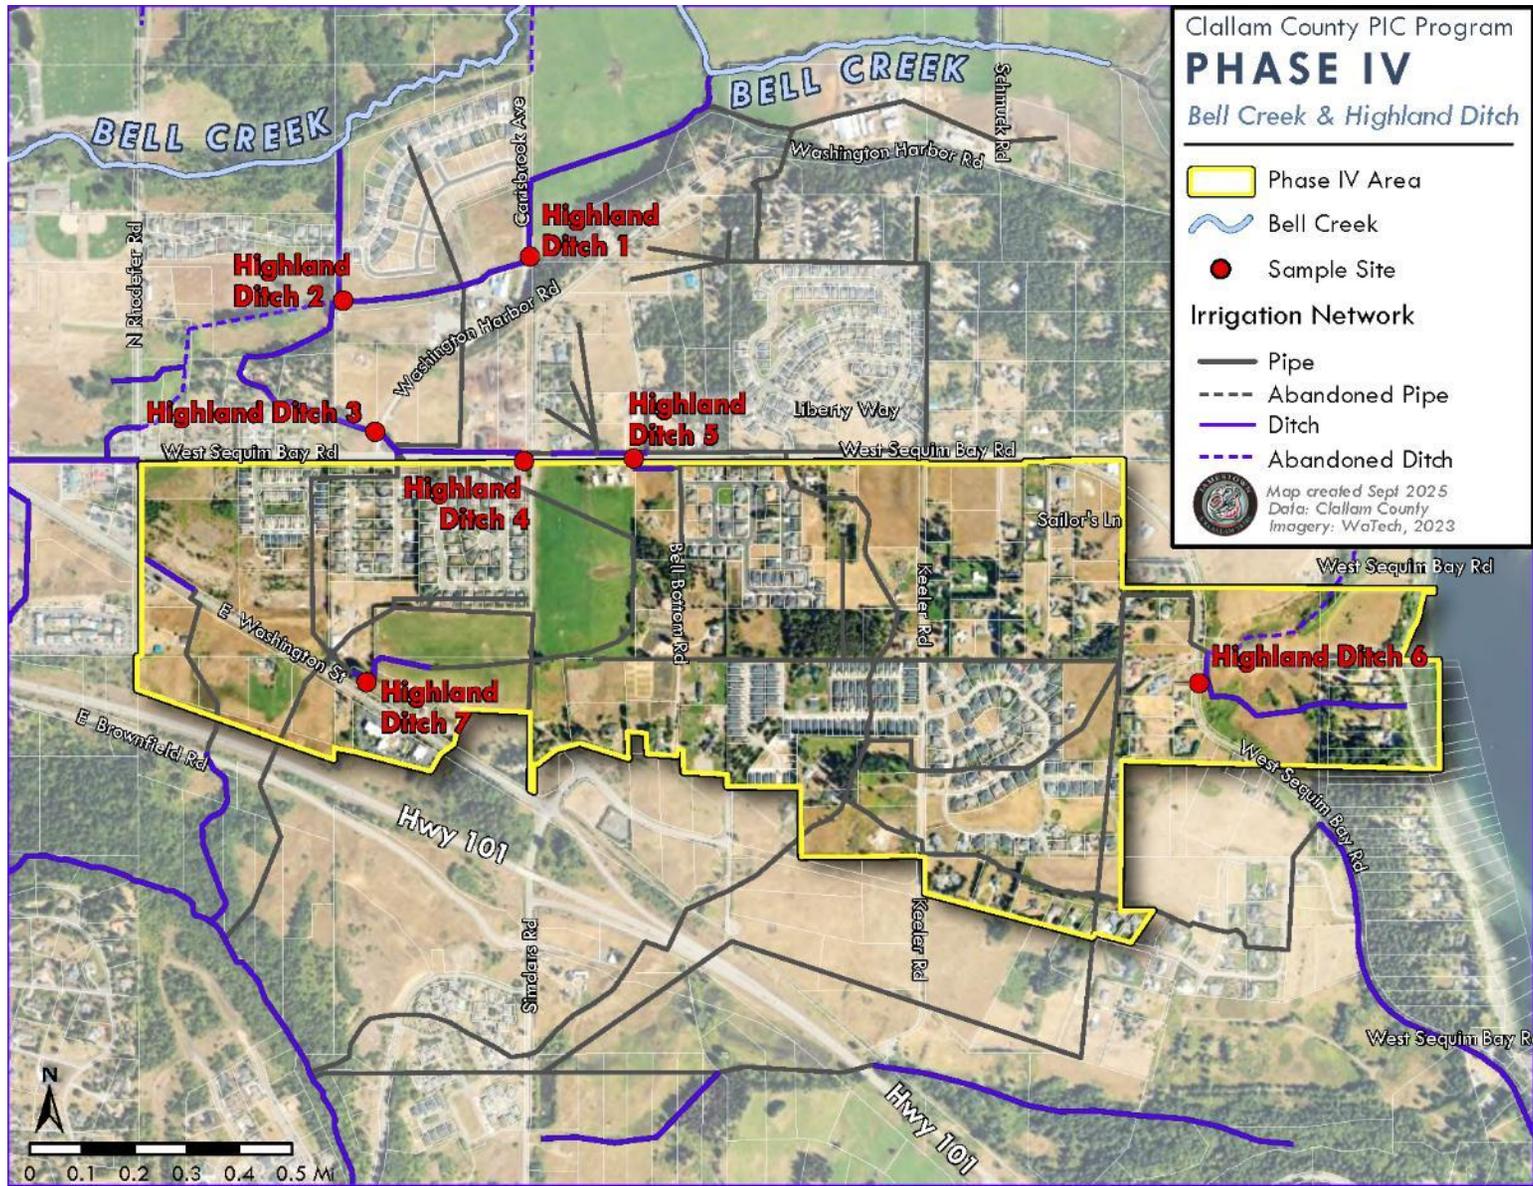
Figure 11. Sequim Bay–Dungeness CWD PIC Phase IV (2023-2025) Highland Irrigation District Focus Area Segmented Sampling locations.

Primary HD Segmented locations (Figure 11) were sampled monthly, from June 2024 through December 2025, with three exceptions (09/2024, 12/2024, and 01/2025). Elevated levels of bacteria were primarily observed at stations HD1, HD3, and a drain between HD4 and HD3. These three locations were designated as high-priority hotspots and investigated through follow-up sampling and coordination with Irrigation District employees. While Septic Inspection Compliance was initiated in this Focus Area, a significant number of the properties are connected to the City of Sequim WWTP, and no OSS failures were identified during inspections.

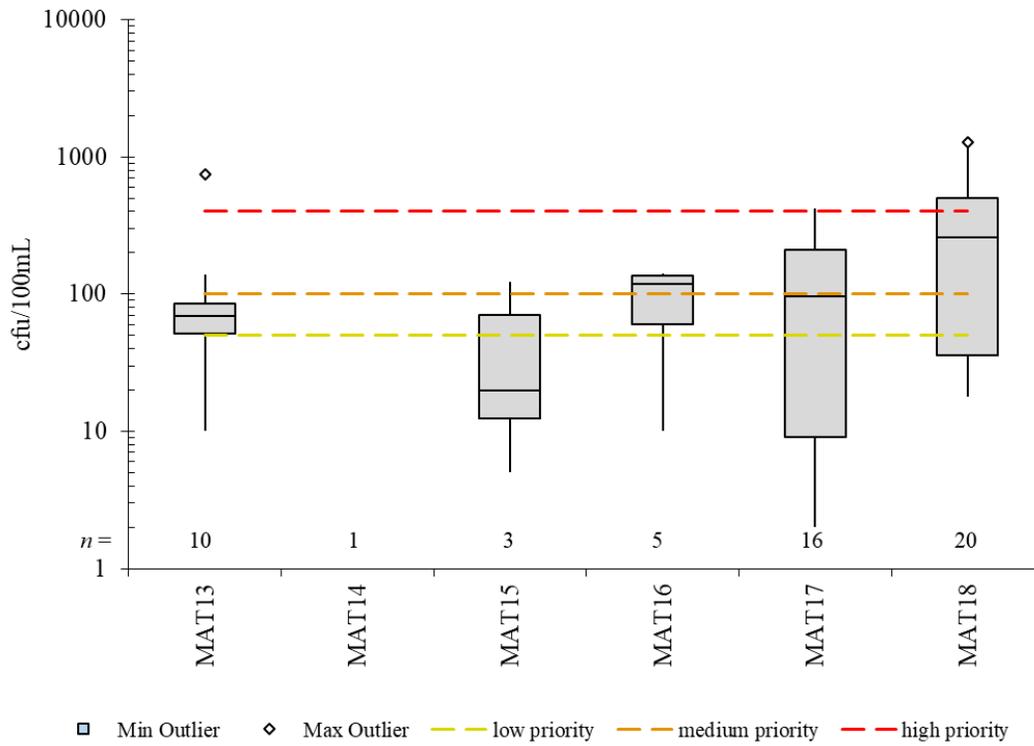
Figure 12. Upper Matriotti Creek Segmented Sampling fecal coliform statistics, Phase IV.

Summary statistics of segmented sampling results for fecal coliform concentrations are presented in Figure 12, Figure 13, and Table 3. No temperature excursions above State water quality criteria were observed at segmented sites during Phase IV. Observed DO excursions, below Core Summer Habitat criteria, are summarized in Table 4.

For statistical analyses, minimum detection limits were substituted for any non-detect values as was the upper countable limit for TNTC results. Primary results were averaged with corresponding laboratory duplicates and reported as composite values. Associated QC are summarized in Table 5. For data displayed as box and whiskers plots, lower and upper hinges correspond to the first and third quartiles. Whiskers extend from the upper and lower hinges to the largest value no further than 1.5x the inner quartile range. Data plotted beyond the whiskers are maximum outliers.

Segmented collections along Upper Matriotti Creek (*n*, Figure 12) were limited at mid stations due to ephemeral conditions caused by a transition from Ilwaco silt loam to Carlsborg gravely-sand loam (between MAT18 and MAT17), then to Puget silt loam (near MAT15), resulting in primarily subsurface flow.

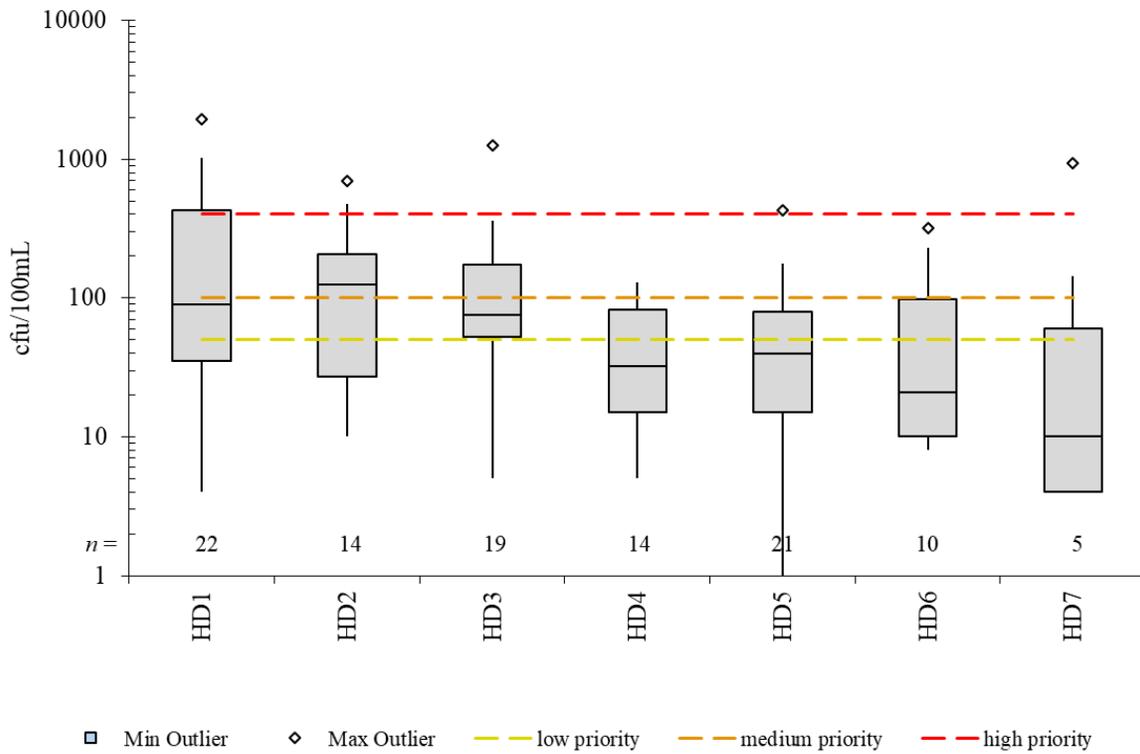
Figure 13. Highland Irrigation Ditch Segmented Sampling fecal coliform statistics, Phase IV.

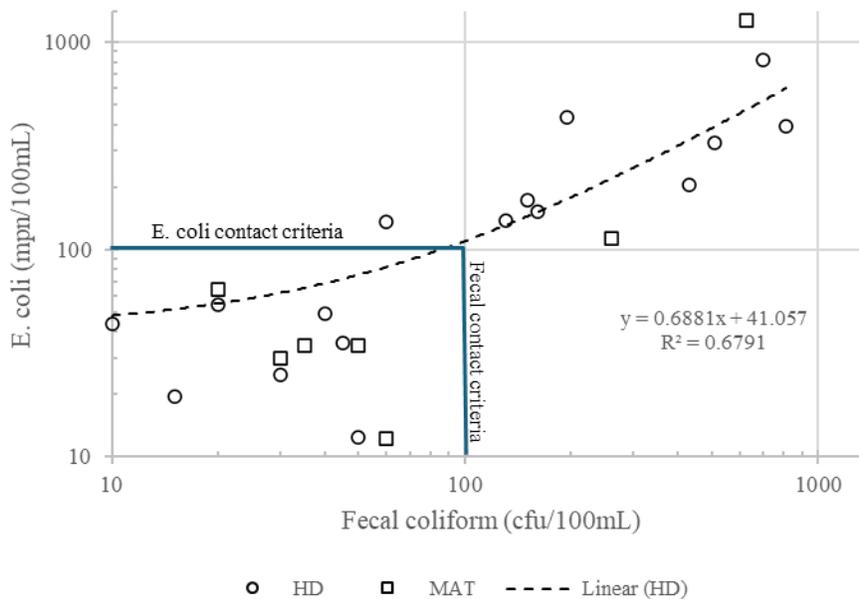
Figure 14. Corresponding grab sample analyses of Escherichia coli and fecal coliform organism levels.

In addition to routine fecal coliform quantification, corresponding *E. coli* grab samples were analyzed for four sampling dates: 03/25/2025, 08/26/2025, 10/28/2025, and 11/12/2025. Concordance of fresh water primary contact recreation bacteria criteria (173A-200 Table 200[2][b]) attainment status, per sample, were observed; with the exception of one outlier (Figure 14).

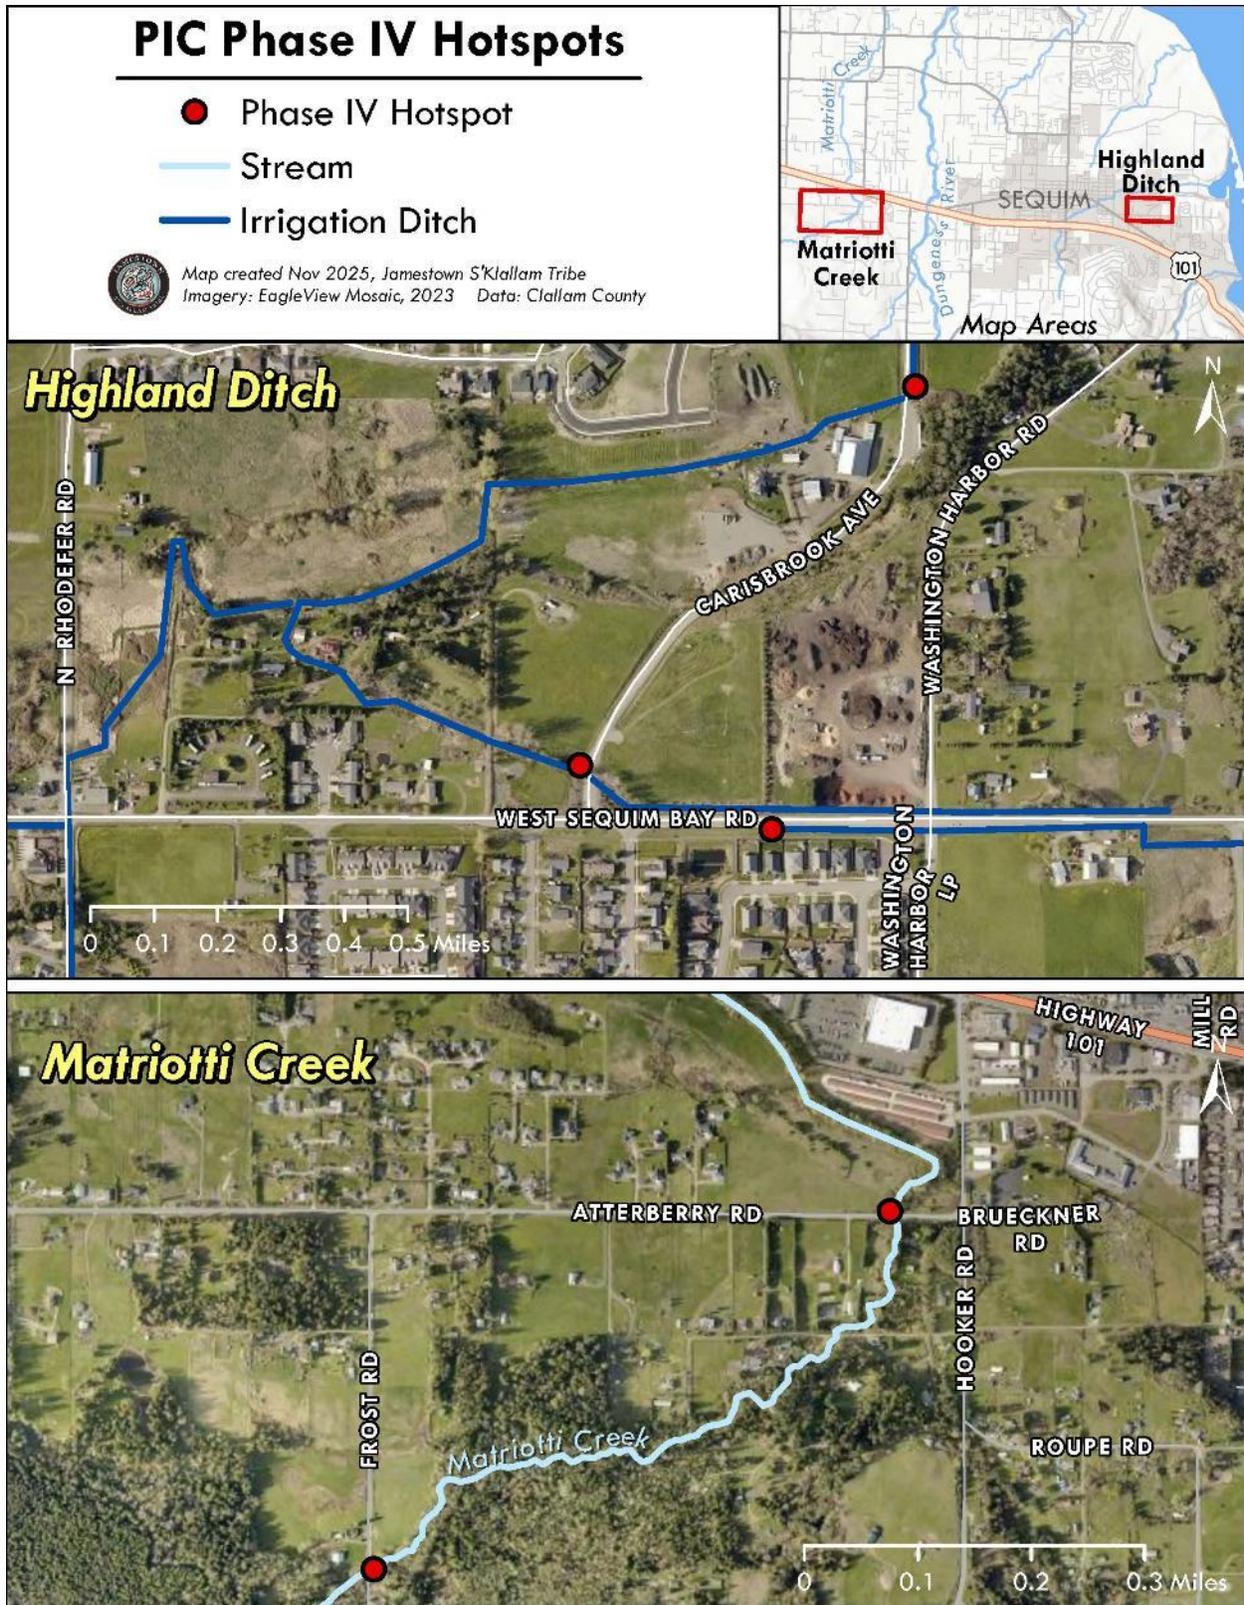
Figure 15. Maps of Highland Ditch and Upper Matriotti Creek hot spots, CWD PIC Phase IV.

Where elevated bacteria levels were found, field teams returned for multiple sampling visits. At least three sequential measurements were used to calculate the geometric means of fecal coliform and characterize sites as hot spots for closer investigation. Ideally, sampling visits for the purpose of hot spot designation occurred in succession, over several days, within an overall period of no more than two weeks after the initial sampling date, given staff availability. If multiple hot spots were found, the following prioritization scheme was implemented: low priority—50 to 99 cfu/100 ml, medium priority—100 to 399 cfu/100ml, high priority—greater than 400 cfu/100 ml. Hot spot designations, summarized in Table 6, included both formal Segmented Sampling sites and locations added to narrow nonpoint sources. Hot spots are mapped in Figure 15 and complete sample tracking spreadsheets are attached in Appendix A.

Hot spots observed on Matriotti Creek (MAT18 and Frost Rd.) were investigated through follow up sampling and inspections, both between and above the sites. Four septic failures were located above Frost Road and routed to CCD for financial assistance: a failure on pn 043029410050 was corrected on 09/03/2025 and correction of a failure on pn 043027220050 was completed on 01/06/2026. Correction of a failures on pn 043027210125 are pn 043021440125 are in progress. Parcel number 043027220050 was also referred to CCD for elevated bacteria where sheep have stream access and remediation is in the planning stage. Between Frost Road and MAT18, pn 043022338025 was referred to CCD after sheep were observed in a tributary and pn 043022430060 was referred for horses accessing Matriotti. In addition, pn 043027210000 was discovered to have occupants without a septic system; a code violation that was referred to the Onsite-Team and is in the process of attaining compliance.

The first hot spot observed on Highland Ditch, HD3, lead to an initial referral of parcels 033028210200, 033021340090, and 033021430025 to CCD for technical assistance. This referral was made through process of elimination of other waters draining to HD3, including one of two irrigation/stormwater pipes that come under West Sequim Bay Road from the south, the irrigation/stormwater ditch on the north side of the road, and the drainage from Cascade Bark's dust suppression pond to the east. The HD3 hotspot was later narrowed to a drain (Grant dr.) that runs through the previously referred parcels. The drain was installed primarily to allow wetland area to be used for cattle grazing and consists of four storm-drain vaults staggered through the pasture's low points. In addition to draining stormwater, groundwater, and irrigation runoff, this line picks up overflows from the pond at HD7, the Highway 101 bypass stormwater collection pond, and a pond on pn 033021430065. Observations indicate the primary source of bacteria to this drain is irrigation season runoff during watering. The correction process is ongoing.
